SERVICE INFORMATION LETTER

Subject: Possible Shaft OD Oversize on Spur Gear PN 422199-100WE

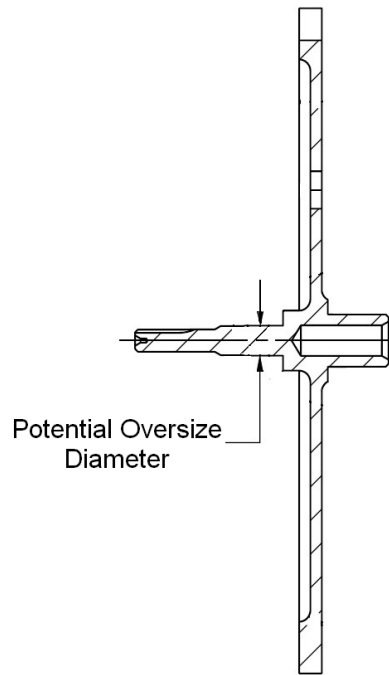
Figure 1, Spur Gear OD Feature

The Wencor design for the subject Spur Gear allowed the possibility of a slightly oversize condition to occur on the outer diameter of the smaller OD shaft on the Spur Gear as shown below in Figure 1.

During the reverse engineering process for the Spur Gear, the size tolerance for the noted diameter was set based upon manufacturing tolerance only. This led to the possibility of the oversize condition by as much as 0.0007", which could prevent installation of the NHA bearing that mates with this shaft. The OD feature has been re-sized to ensure the correct fit under all conditions.

The possibility of the oversize diameter was discovered when a customer attempted to install the NHA bearing onto the shaft of the Spur Gear and discovered that the bearing would not install due to the oversized diameter.

In the event of an oversized shaft on the Spur Gear, and depending upon the actual ID size of the mating bearing, the assembly of the bearing onto the shaft would be prevented if the OD was 0.0003" – 0.0007" oversize. However if the OD was only 0.0001" - 0.0002" oversize, the bearing would still likely be installed and would not result in any noticeable in-service performance of the bearing or the Trimmable Horizontal Stabilizer Actuator.

For any Wencor Spur Gear's that are currently uninstalled that have the oversize condition should be returned to Wencor for replacement because this condition most likely prevents the NHA bearing from being installed.

However, any Wencor Spur Gear that are currently installed, passed the ATP for the Trimmable Horizontal Stabilizer Actuator and are in service may remain in service at the discretion of the end user without any change in aircraft safety.

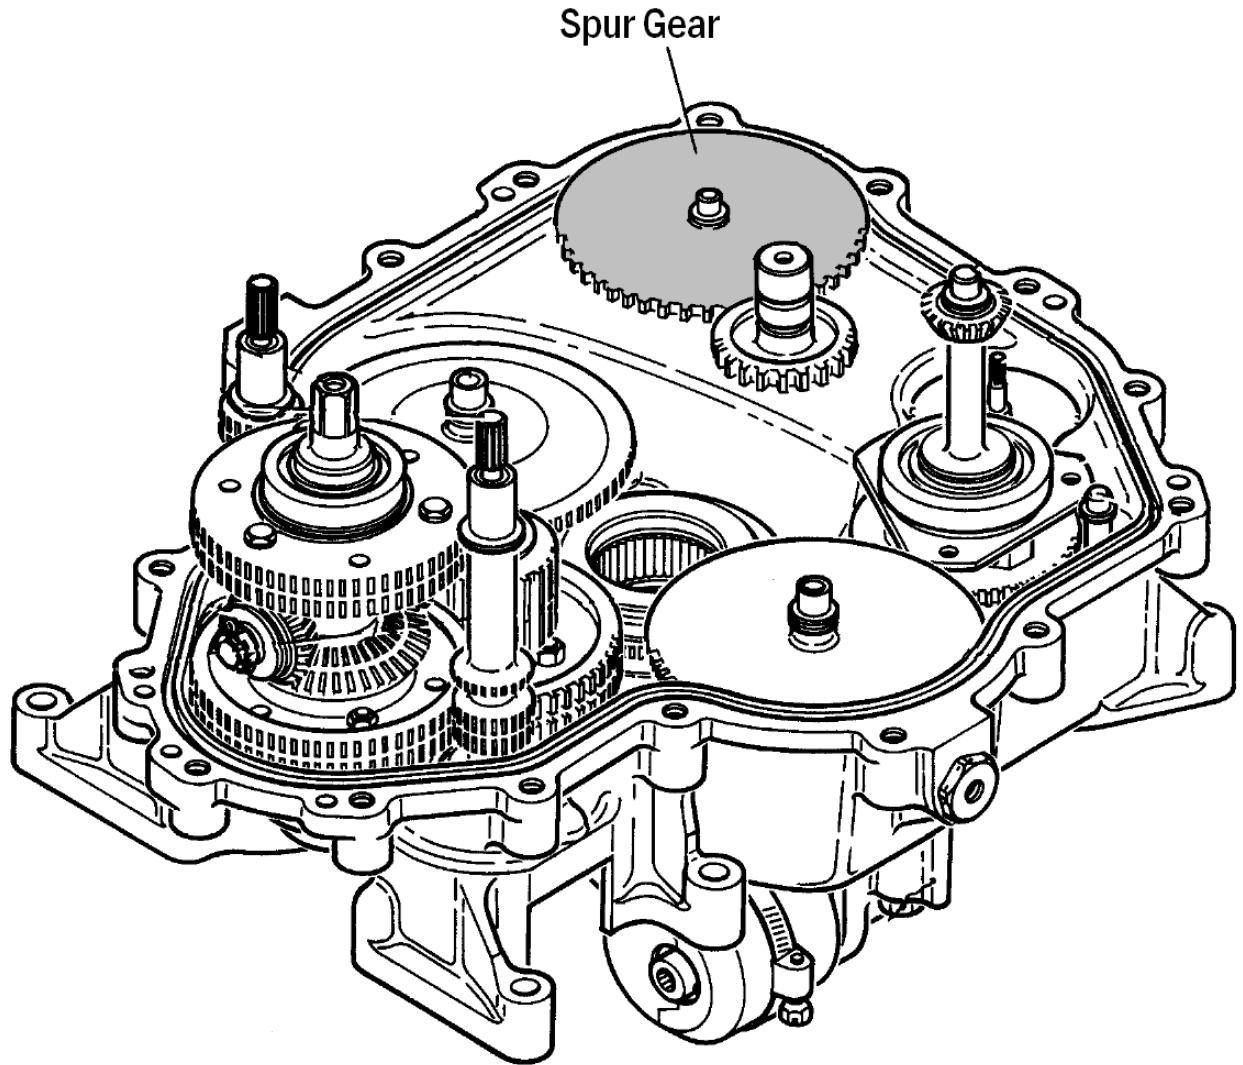
Figure 2, Spur Gear Installed into the THSA Gearbox

The Spur Gear is installed into the gearbox section of the Trimmable Horizontal Stabilizer Actuator as shown in Figure 2 and acts as one of the coupling links between the position transducer unit and the ball screw.
